# BOLTED FIELD REPAIR OF COMPOSITE STRUCTURES

J. C. Watson, et al.  
McDonnell Douglas Corporation  
McDonnell Aircraft Company  
P.O. Box 516  
St. Louis, Missouri 63166

Final Report

Repairs were demonstrated on both laminate thicknesses. The 3/16 inch laminate was typical of an AV-8B wing skin. The 1/2 inch laminate was typical of an F-18 wing skin. Three sizes of damage holes were investigated for each laminate thickness: 1.0 in., 2.5 in., and 4.0 in. diameters. Two repair concepts were evaluated for each damage configuration.

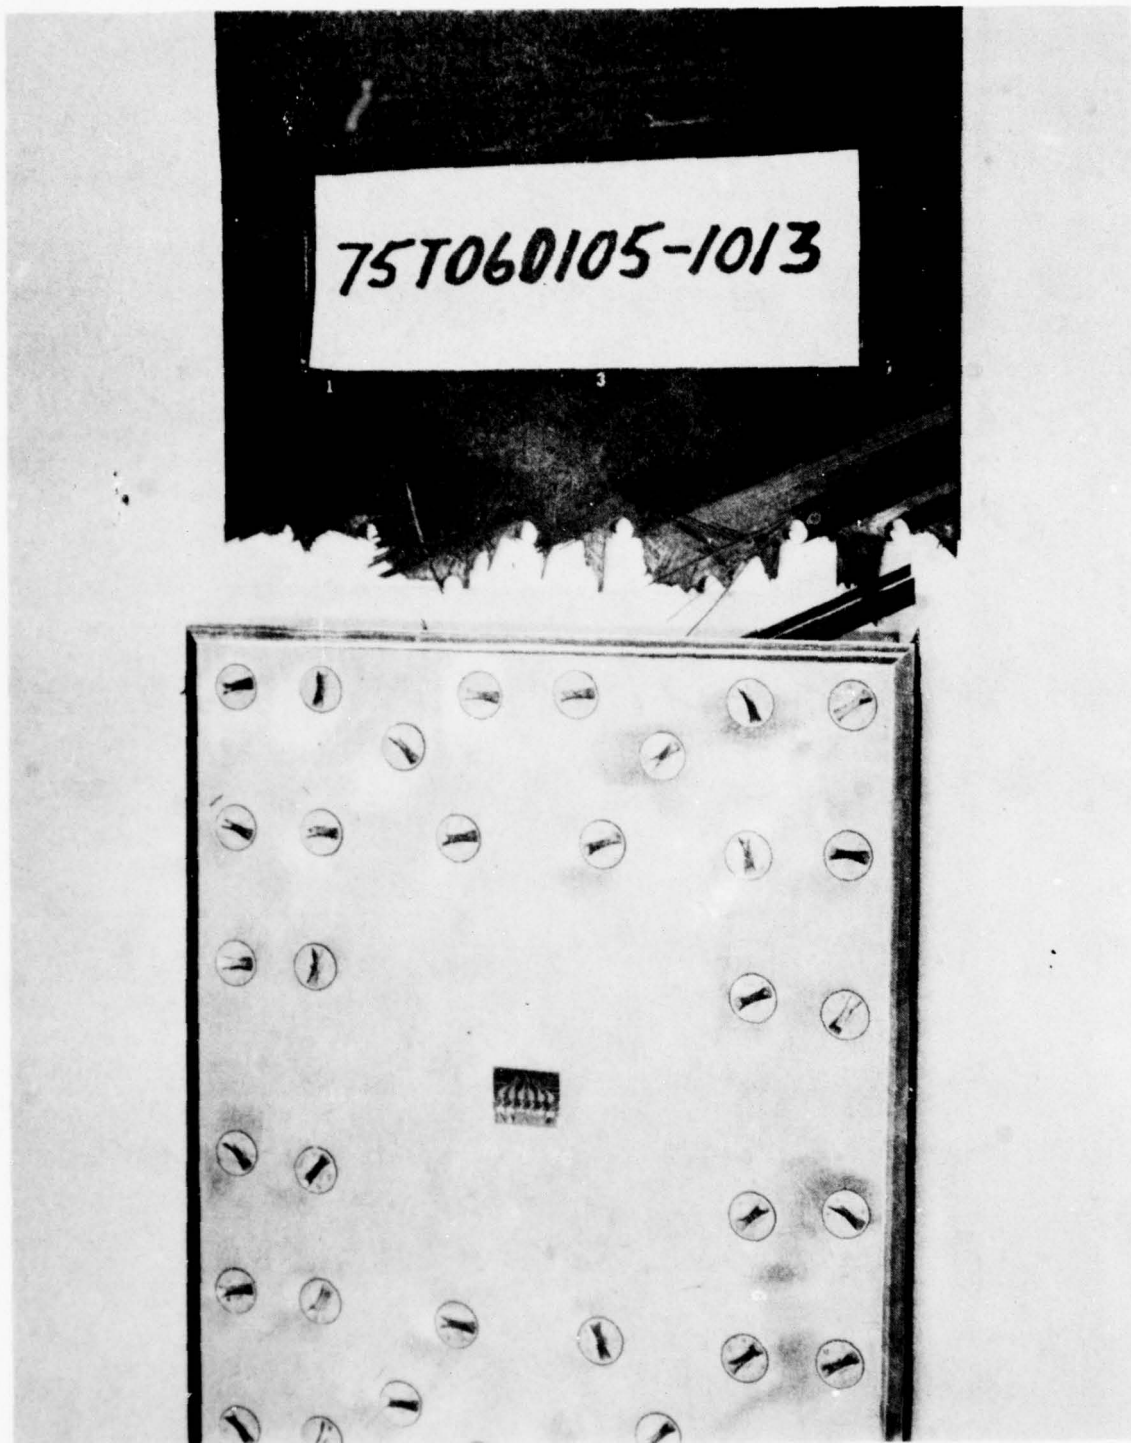
FIGURE 3-16  
FAILED 75T060105-1013 SPECIMEN  
3/16 Laminate 4.0 Diameter Damage Hole

The initial test on the 5/16 inch fastener configuration brought failure at 62,500 lb and a gross laminate strain of 4,540  $\mu\text{in./in.}$  The 1/4 in. fastener concept failed at 65,500 lb and 4,758  $\mu\text{in./in.}$  strain. Both failures were along an outermost row of fasteners. Figures 3-15 and 3-16 show the failures. Both concepts thus exceeded 4,000  $\mu\text{in./in.}$ , with the 1/4 in. dia. fastener concept slightly better.

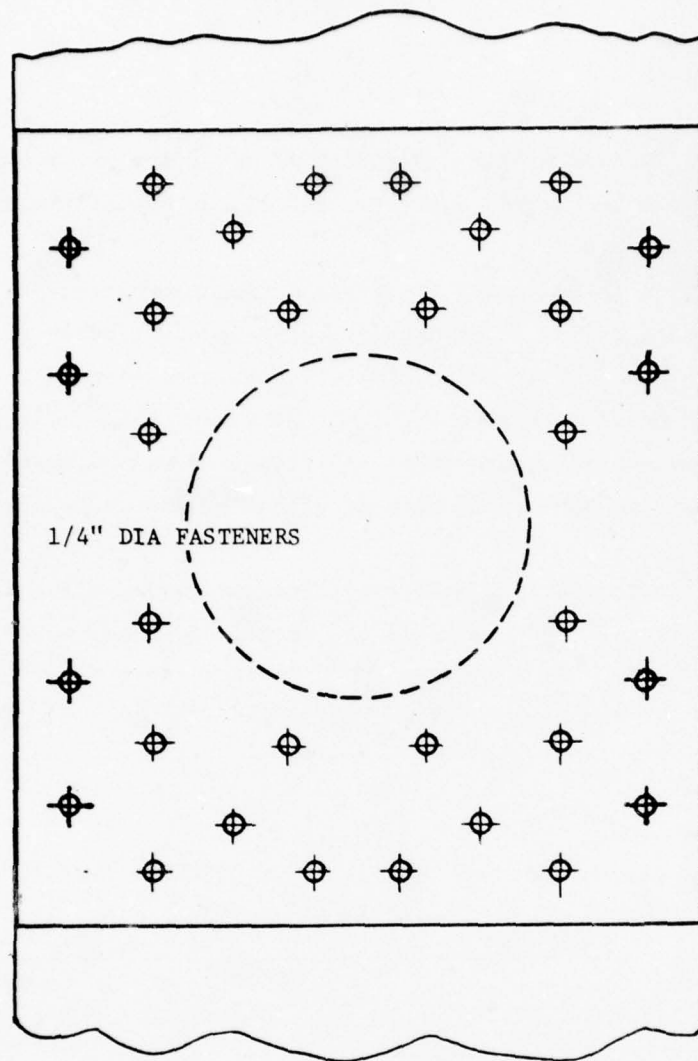
75T060105-1015 ASSEMBLY

Part Name	Drawing Part Numbers
Repair Assy	75T060105-1015
Patch Details	75T060103-2013/-1015
Gr/Ep Specimen	75T060101-1005

FIGURE 3-17 3/16 LAMINATE 4.0 DIA DAMAGE HOLE FOLLOW-ON TEST DESIGN

It was hoped that further improvement could be made if the number of fasteners in the outermost row were reduced, to reduce the perforated effect along the failure location in the first test. Thus, the 75T060105-1015 assembly was created. This concept is basically the same as the previous 1/4 in. fastener concept (75T060105-1013), except that it had four fasteners

along each edge instead of six. Figure 3-17 lists the parts in the new assembly. (Reference Figures A-1, A-3, and A-5 in Appendix A), shows the revised fastener pattern.

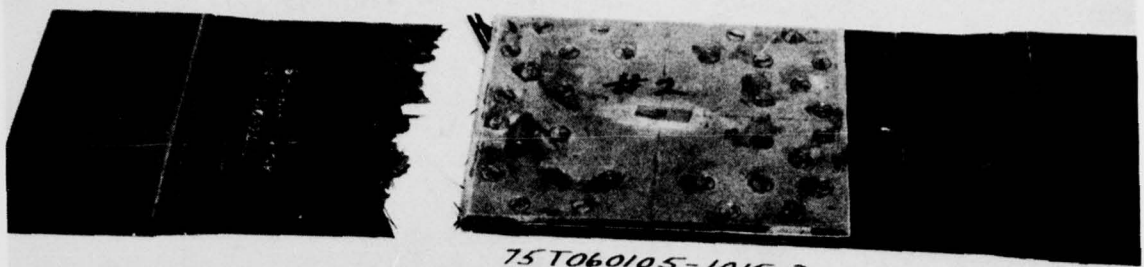
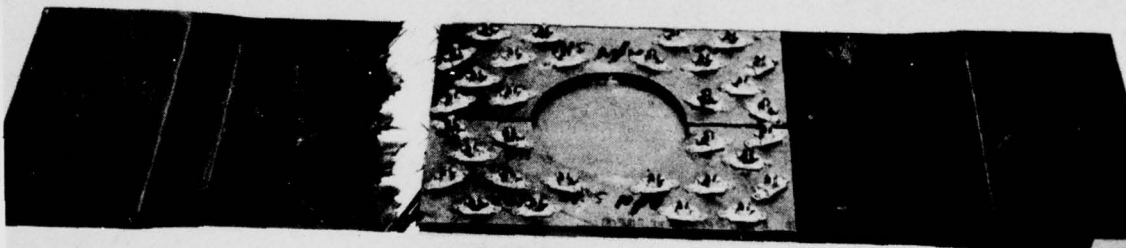
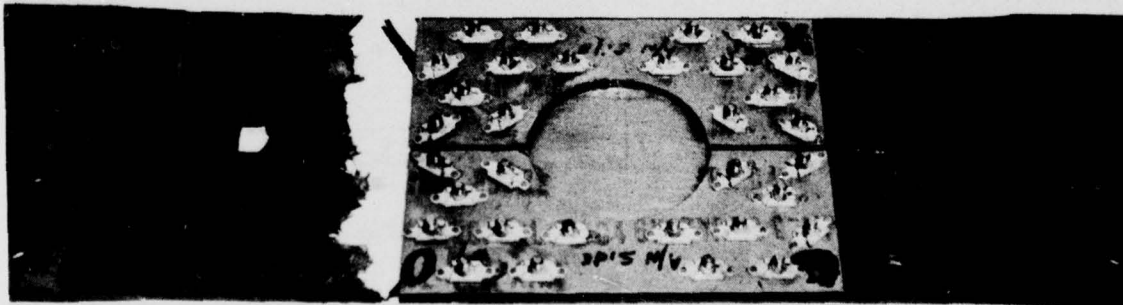
FIGURE 3-18  
 FAILED 75T060105-1015 SPECIMENS  
 3/16 Laminate 4.0 Diameter Damage Hole

The follow-on tests showed the revised fastener pattern offered no significant load carrying improvement. Failures occurred at 64,500 lb and 67,500 lb (4758  $\mu$ in./in. respectively). The failure mode was again along the outer row of fasteners at one end of the patch. This is shown in Figure 3-18. An overall improvement in efficiency can be noted, since the number of fasteners was reduced with no effect on the load-carrying capability of the repair.

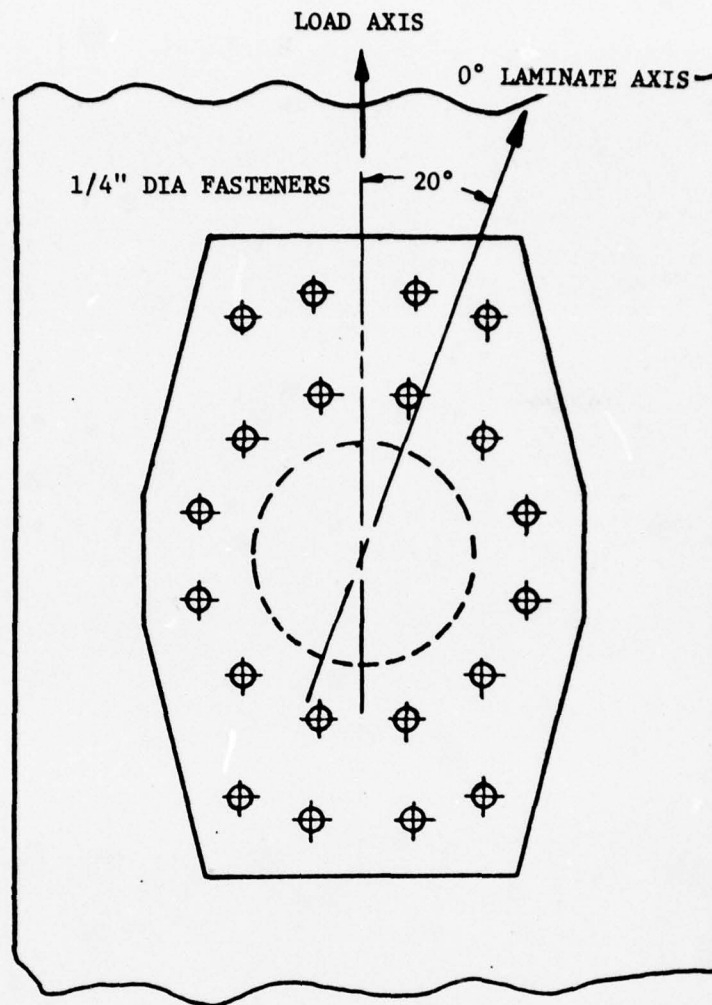
75T060105-1017 ASSEMBLY

Part Name	Drawing Part Numbers
Repair Assy	75T060105-1017
Patch Details	75T060103-2001/-1001
Gr/Ep Specimen	75T060101-1009

FIGURE 3-19 3/16 LAMINATE OFF-AXIS REPAIR DESIGN

The Gr/Ep panel was fabricated with the 0° laminate axis 20° off the load axis. The patch was attached in line with the load. Figure 3-19 shows the assembly and a table of parts. Engineering drawings are found in Figures A-1, A-3 and A-5, Appendix A.

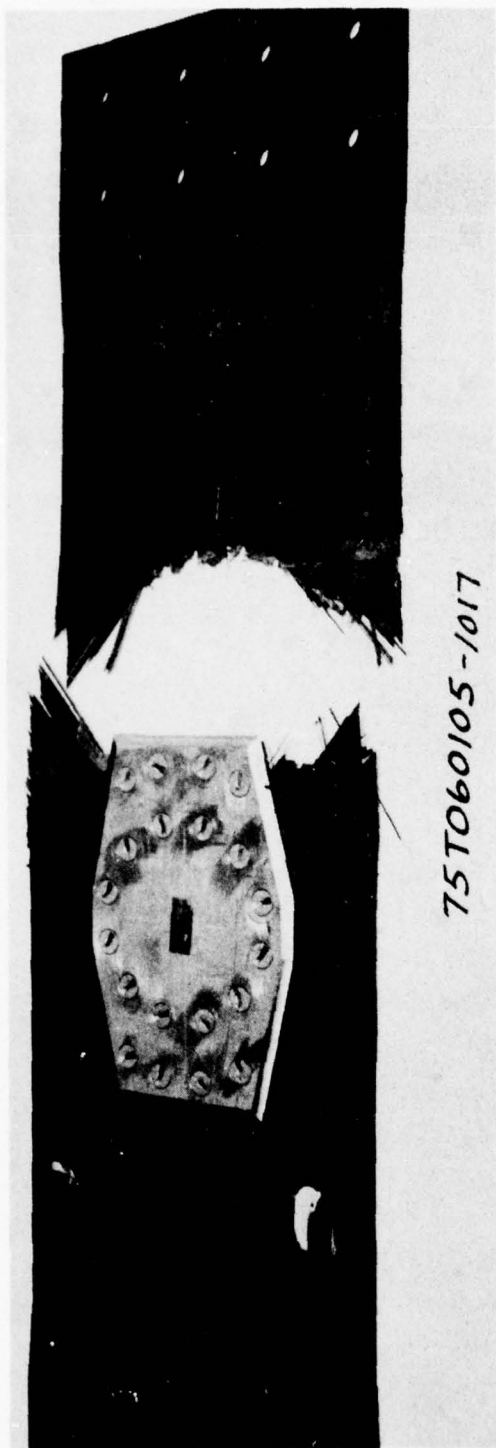
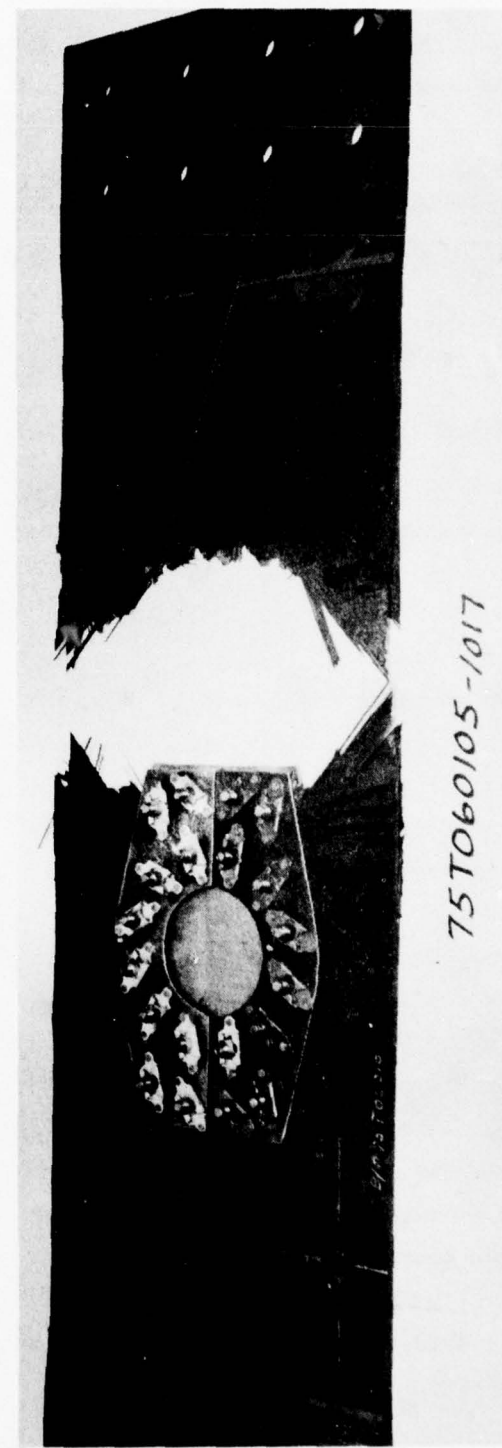
FIGURE 3-20  
FAILED 3/16 LAMINATE OFF-AXIS SPECIMEN

The specimen failed at a load of 73,300 lb and an average laminate strain, in the load direction, of 6,233  $\mu$ in./in. The specimen failed across the outer row of fasteners. The maximum strain measured was 10,981  $\mu$ in./in., see Figure 3-20. This test showed the structural adequacy of an off-axis repair. The patch performs similar to its on-axis counterpart (Section 3.3).

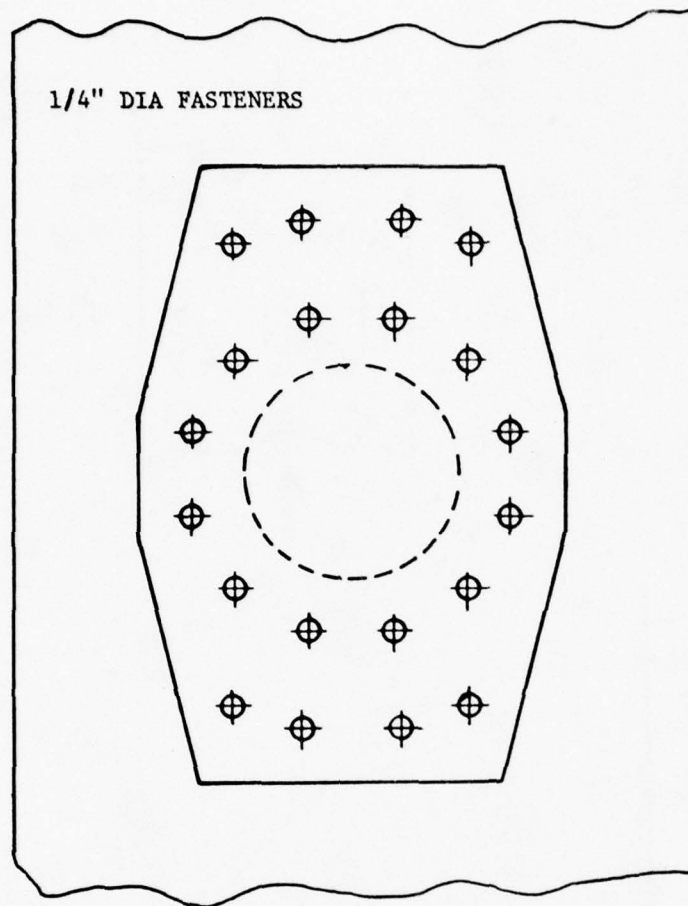
FIGURE 3-21 3/16 LAMINATE COMPRESSION REPAIR DESIGN

75T060105-1009 ASSEMBLY

Part Name	Drawing Part Numbers
Repair Assy	75T060105-1009
Patch Details	75T060103-2001/-1001
Gr/Ep Specimen	75T060101-1007

The patch used to repair the hole on the 3/16 in. laminate compression specimen was one with twenty 1/4 in. fasteners used on the tension test of the 2.50 in. hole. Figure 3-21 shows a sketch of the repair and a table of parts.

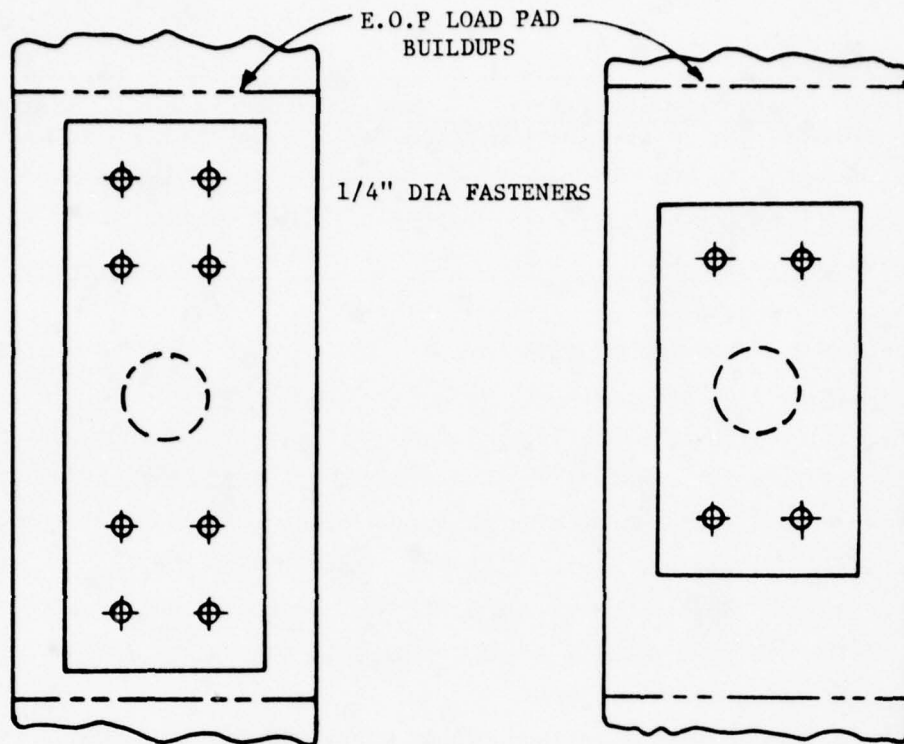
FIGURE 3-23 1/2 LAMINATE 1.0 DIA DAMAGE HOLE REVISED PATCH DESIGNS

75T060106-1019 ASSEMBLY

75T060106-1021 ASSEMBLY

Part Name	Drawing Part Numbers	
	8-Bolt Configuration	4-Bolt Configuration
Repair Assy	75T060106-1019	75T060106-1021
Patch Details	75T060104-2011/-1015	75T060104-2013/1017
Gr/Ep Specimen	75T060101-1011	75T060101-1011

Figure 3-23 shows the revised repair patch designs and their parts list for the 1/2 inch laminate.

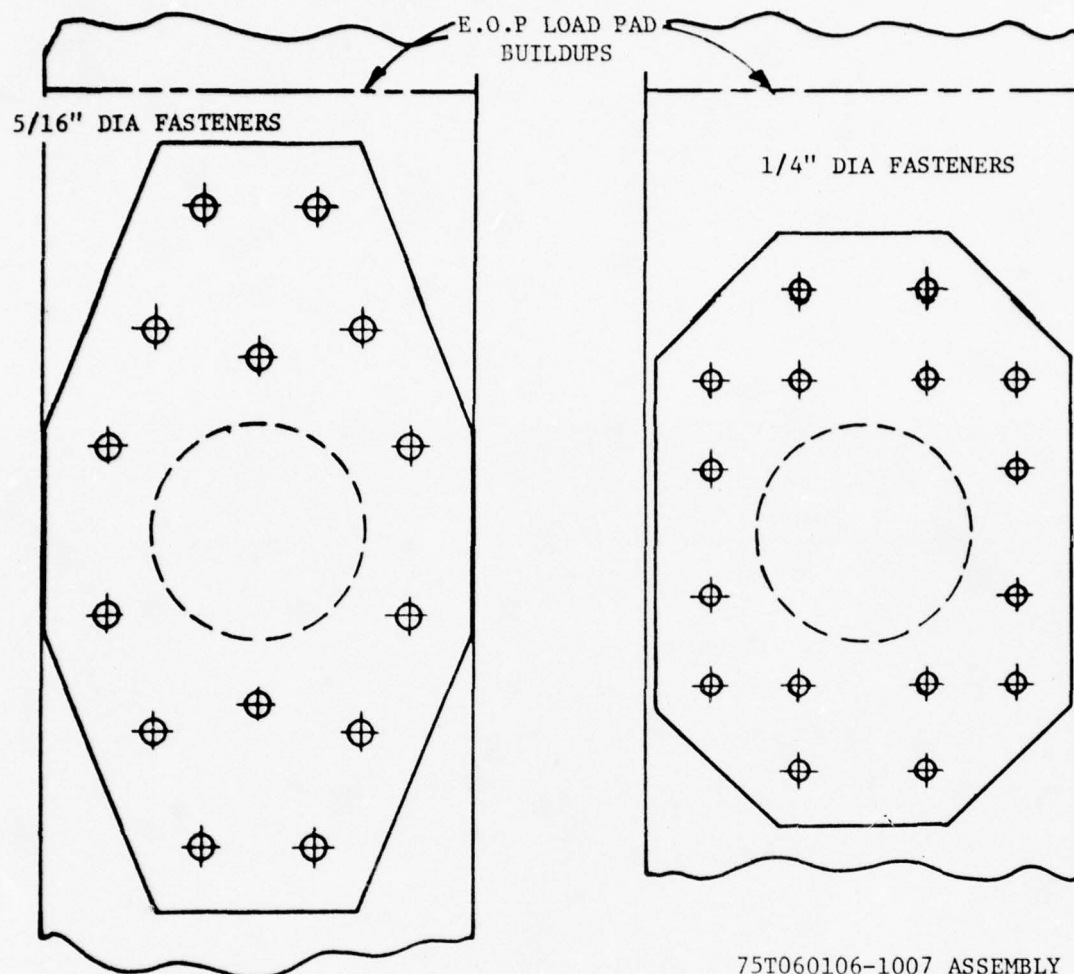
FIGURE 3-25 1/2 LAMINATE 2.5 DIA DAMAGE HOLE REPAIR DESIGNS

75T060106-1007 ASSEMBLY  
(TITANIUM PATCH)

75T060106-1017 ASSEMBLY\*  
(STEEL PATCH)

Part Name	Drawing Part Numbers	
	5/16 in. Fastener Config	1/4 in. Fastener Config
Repair Assy	75T060106-1005	75T060106-1007
Patch Details	75T060104-2003/-1007	75T060104-2001/-1005
Gr/Ep Specimen	75T060101-1013	75T060101-1013

Figure 3-25 shows the two repair assemblies for a 1/2 in. laminate with a 2.50 in. hole. The table included in that figure lists the components in the assemblies (Ref Appendix A, Figures A-1, A-4 and A-6) developed using 1/4 in. dia bolts in one patch and 5/16 in. dia bolts in the other.

The first follow-on test was performed on a repair which was identical in geometry to the 75T060106-1007 (1/4 in. bolts), except the patch and backing plate were made of stainless steel. The modulus of steel is roughly twice that of titanium, and is the same material used for repair patches on F-4 aircraft. The assembly is the 75T060106-1017 specimen as noted in Figure 3-25.

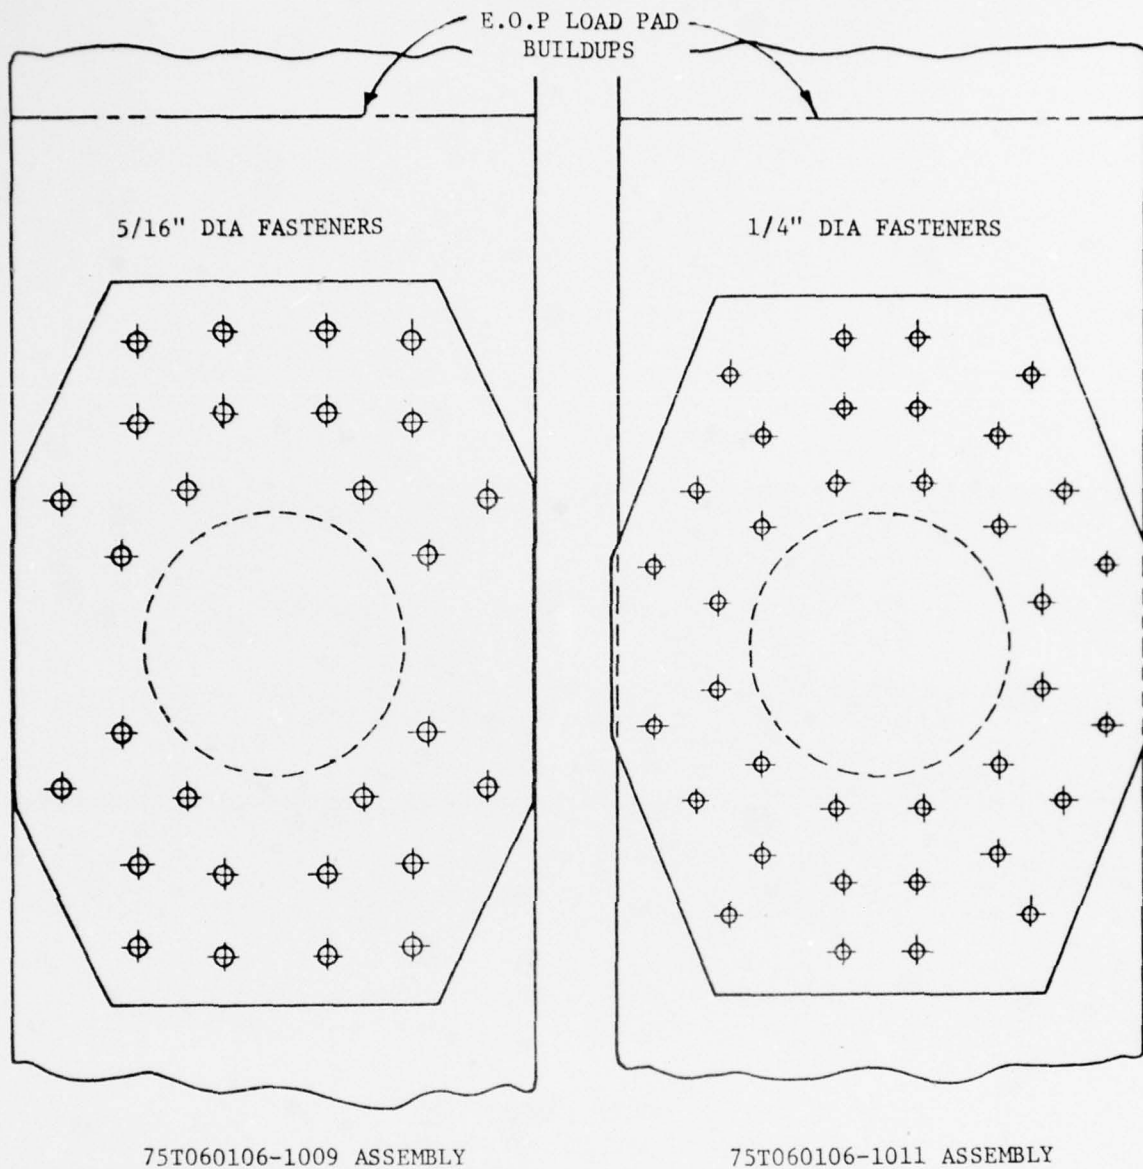
FIGURE 3-28 1/2 LAMINATE 4.0 DIA DAMAGE HOLE REPAIR DESIGNS

Part Name	Drawing Part Numbers	
	5/16 in. Fastener Config (28 Fasteners)	1/4 in. Fastener Config (36 Fasteners)
Repair Assy	75T060106-1009	75T060106-1011
Patch Details	75T060104-2005/-1009	75T060104-2007/-1011
Gr/Ep Specimen	75T060101-1015	75T060101-1015

The two repair configurations designed for a 1/2 in. laminate with a 4.0 inch dia damage hole are sketched in Figure 3-28. The table in that figure list the detailed parts which go into each assembly (Ref Appendix A, Figures A-1, A-4 and A-6). One configuration, 75T060106-1009 has twenty-eight 5/16 in. fasteners. The other repair patch has thirty-six 1/4 in. fasteners (75T060106-1011).

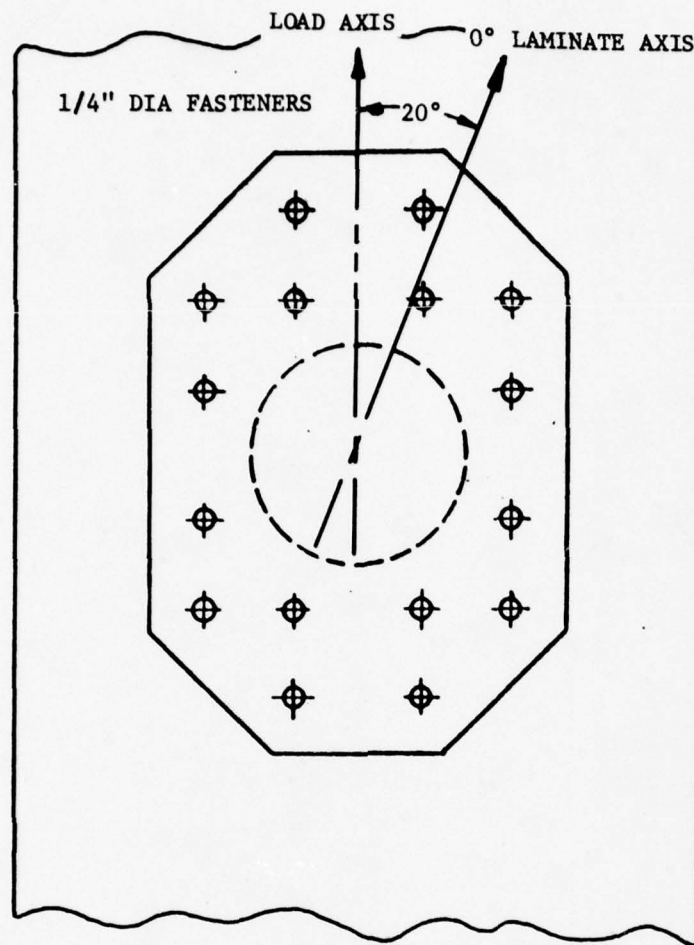
FIGURE 3-31 1/2 LAMINATE OFF-AXIS REPAIR DESIGN

75T060106-1013 ASSEMBLY

Part Name	Drawing Part Numbers
Repair Assy	75T060106-1013
Patch Details	75T060104-2001/-1005
Gr/Ep Specimen	75T060101-1019

The patch chosen for the 1/2 in. laminate off-axis specimen was the 1/4 in. fastener design for a 2.50 in. hole. Figure 3-31 is a drawing of the patch configuration and a table listing the parts in the assembly. (Refer to the engineering drawings, Figures A-1, A-4, and A-6 in Appendix A.

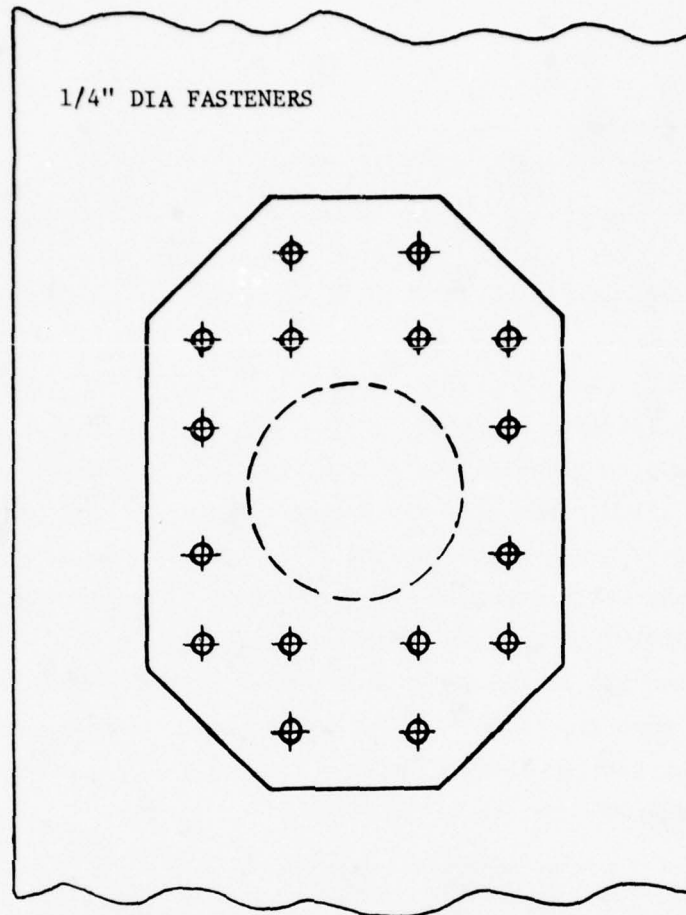
FIGURE 3-33 1/2 LAMINATE COMPRESSION REPAIR DESIGN

75T060106-1015 ASSEMBLY

Part Name	Drawing Part Numbers
Repair Assy	75T060106-1015
Patch Details	75T060104-2001/-1005
Gr/Ep Specimen	75T060101-1017

The repair patch used on the 1/2 in. laminate compression specimen was the design which performed best on the tension test of the 2.50 in. dia hole. Figure 3-33 shows the patch and a list of component parts.

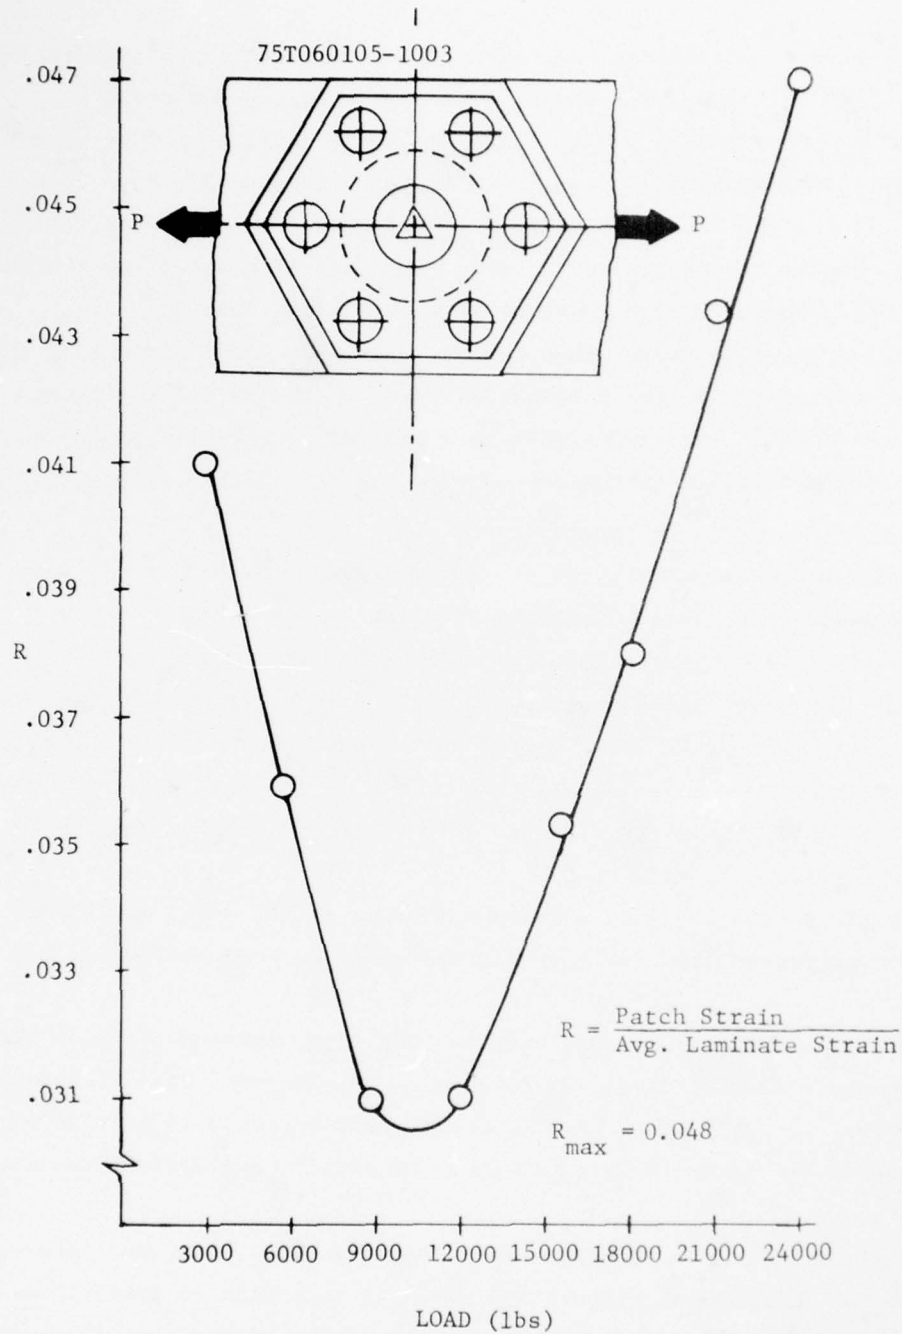
FIGURE 4-1 PLOT OF RATIO OF REPAIR PATCH STRAIN/GROSS LAMINATE STRAIN VS. LOAD  
FOR 75T060105-1003

Initially, due to fastener clearances, the only load transferred to the patch is through friction. Consequently the patch strain increases at a lower rate than the laminate strain. This causes a decrease in the strain ratio (R) with increasing load. At 9,000 lb the fasteners begin to load the patch. As fastener clearances are gradually overcome by strain, the strain ratio begins to increase with load. When all clearances are removed the strain ratio should remain constant with increasing load.

Figure 4-1 shows positive slope up to the failure point indicating that the specimen failed before the fastener clearances allowed fully effective loading on the patch. This inference is supported by a review of the test data. The specimen failed in the net section and very little strain (200  $\mu\text{in./in.}$ ) was measured on the patch.

Frictional clamp-up between the patch and panel was ignored. Careful analysis of the test data shows evidence that frictional forces did exist. Figure 4-1 shows a plot of load vs. the ratio of patch strain to laminate strain for the 75T060105-1003 specimen. In the absence of friction and fastener clearance, the strain ratio would be constant for all load levels. However, the test data shows that the ratio initially starts at a high value, then drops rapidly as the loading is increased, until at 9,000 lb., the ratio bottoms out and then begins increasing with load all the way to failure.

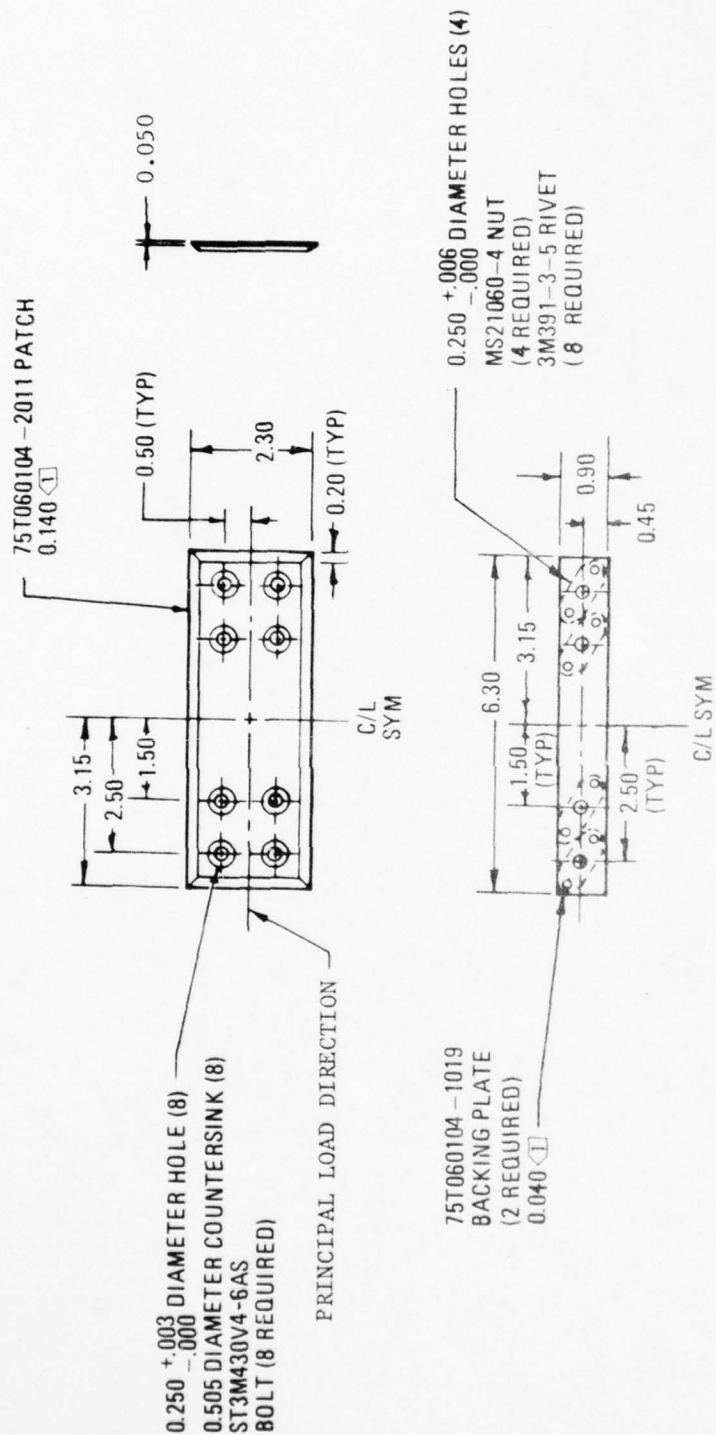
FIGURE 6-2 REPAIR OF 3/16 INCH LAMINATE

REPAIR OF 1.0 INCH HOLE IN 3/16 INCH LAMINATE

Damage to 3/16-inch thick graphite/epoxy laminated skin, which can be enclosed in a 1 to 4-inch circle, may be repaired using the mechanically fastened titanium alloy patches and backing plates shown in Figure 6-2.

Patches, 75T060104-2011, 75T060103-2001 or 75T060103-2013  
per Figure 6-2 for 3/16-in. laminates

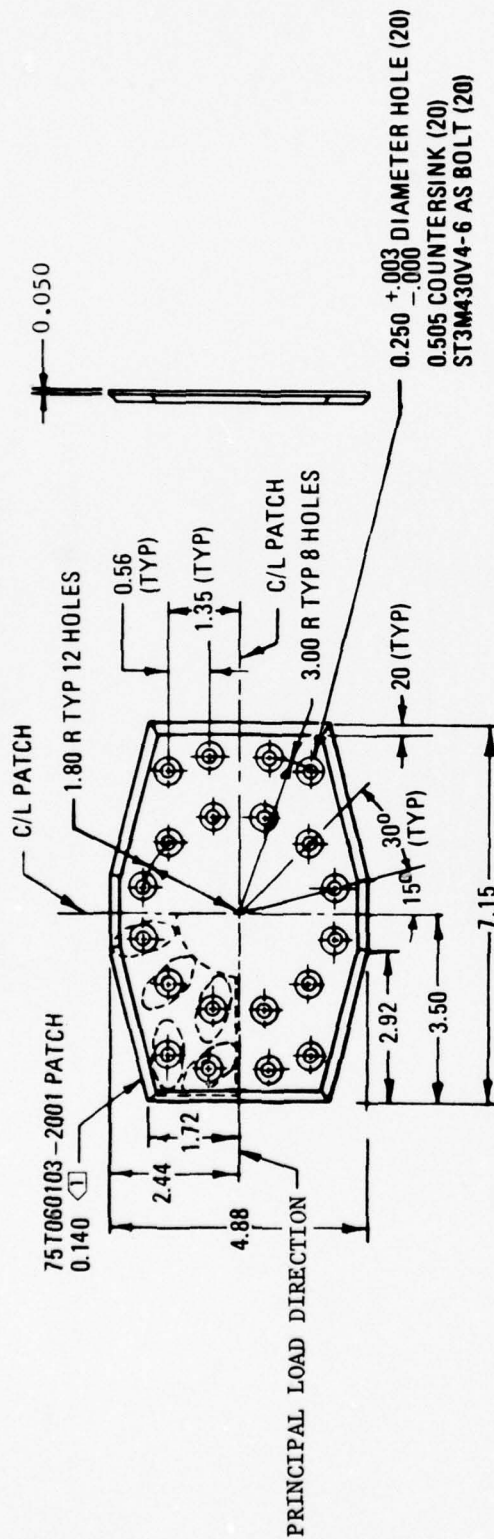
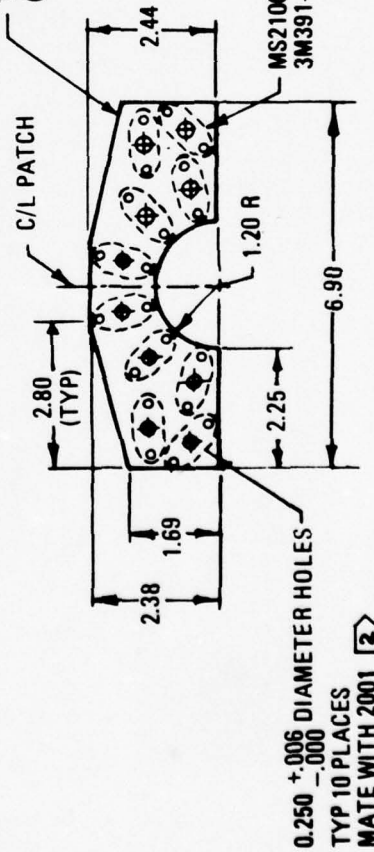
FIGURE 6-2 CONTINUED

75T060103 - 1001 BACKING PLATE  
(2 REQUIRED) 0.040

REPAIR OF 2.5 INCH HOLE IN 3/16 INCH LAMINATE

Backing Plates (2), 75T060104-1019, 75T060103-1015 or 75T060103-1001  
per Figure 6-2 for 3/16-in. laminates

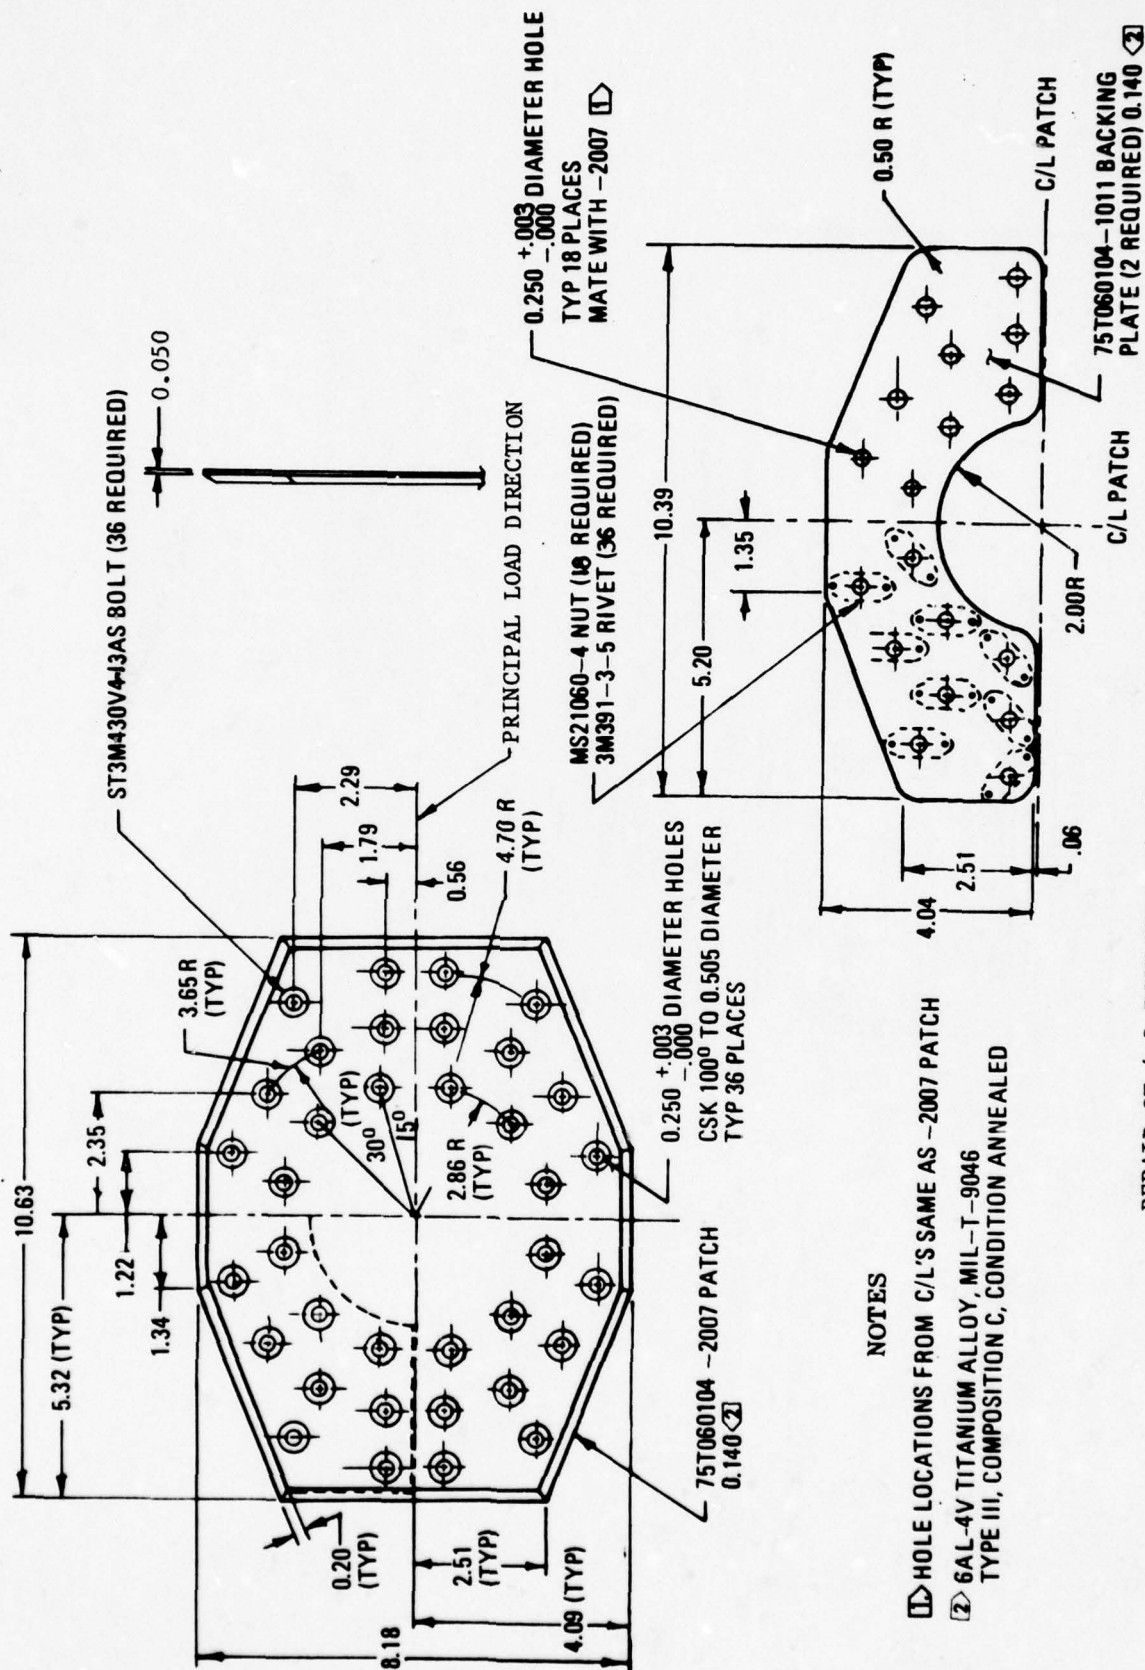
FIGURE 6-3 CONTINUED

REPAIR OF 4.0 INCH HOLE IN 1/2 INCH LAMINATE

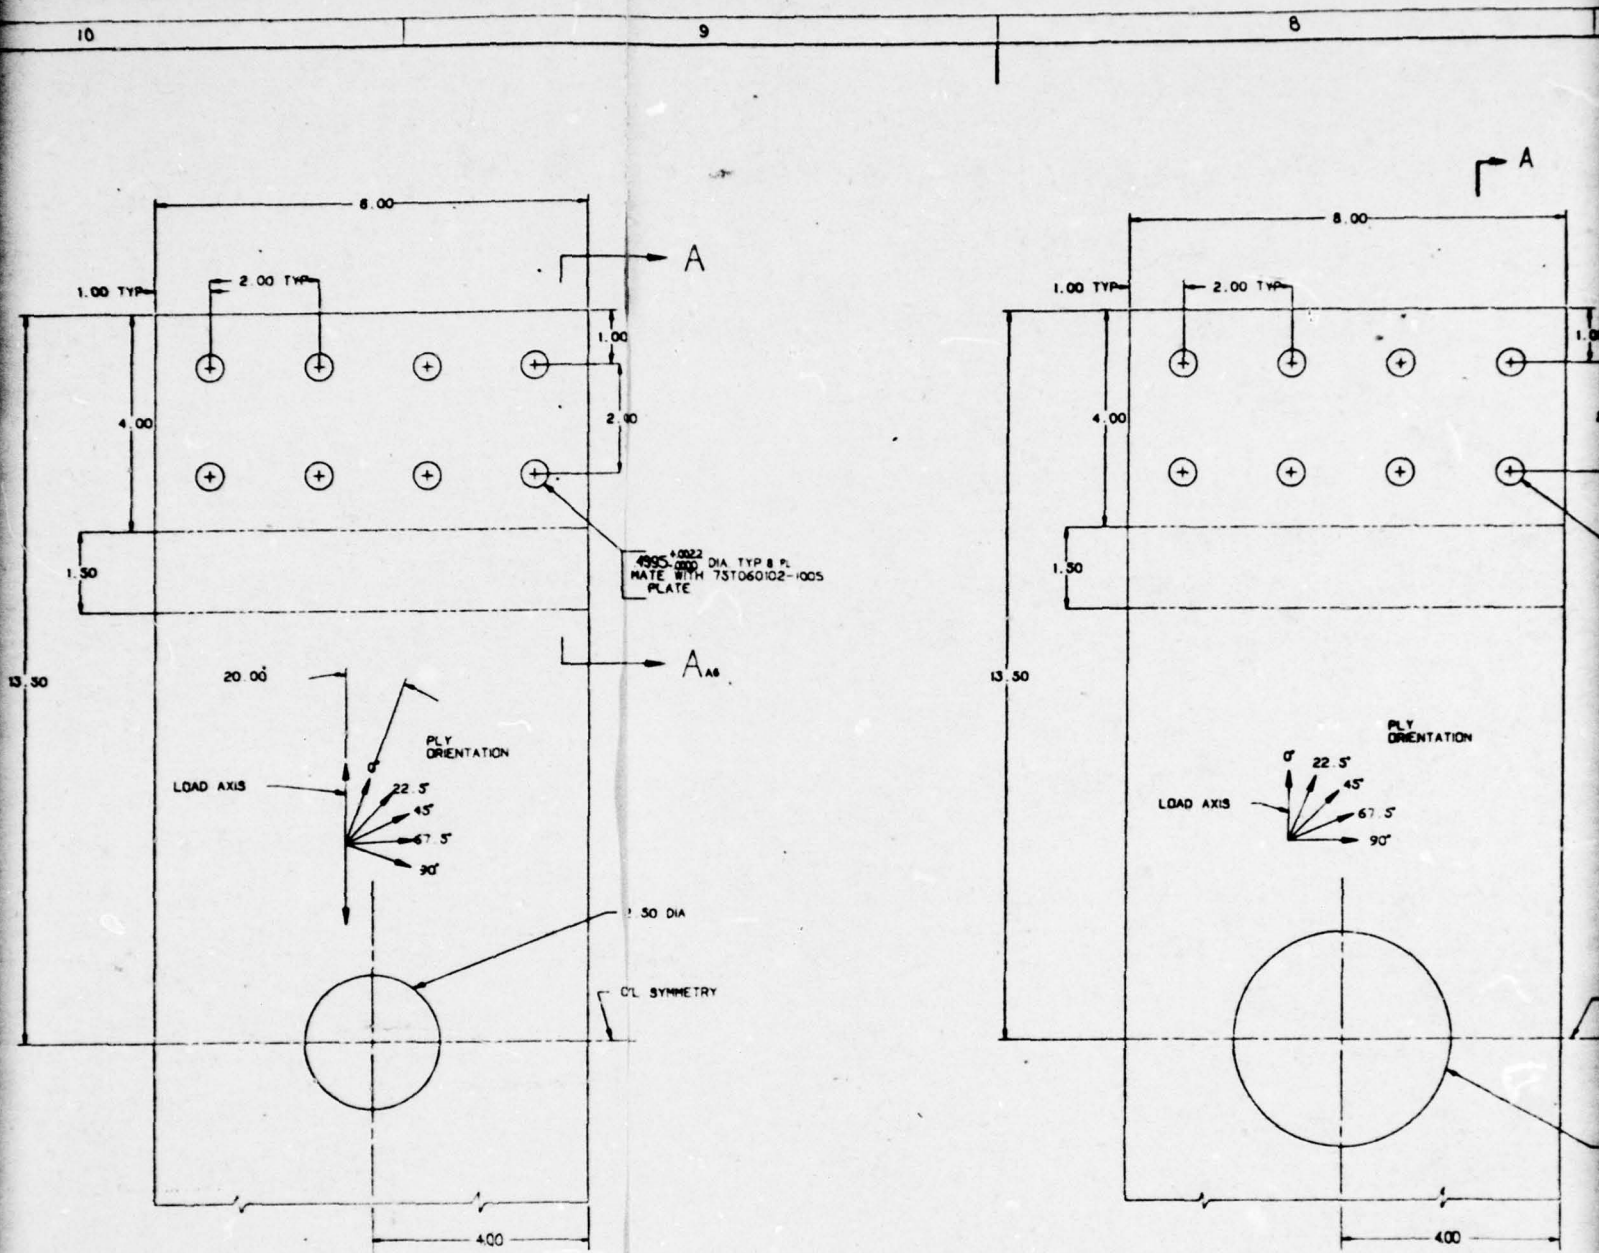
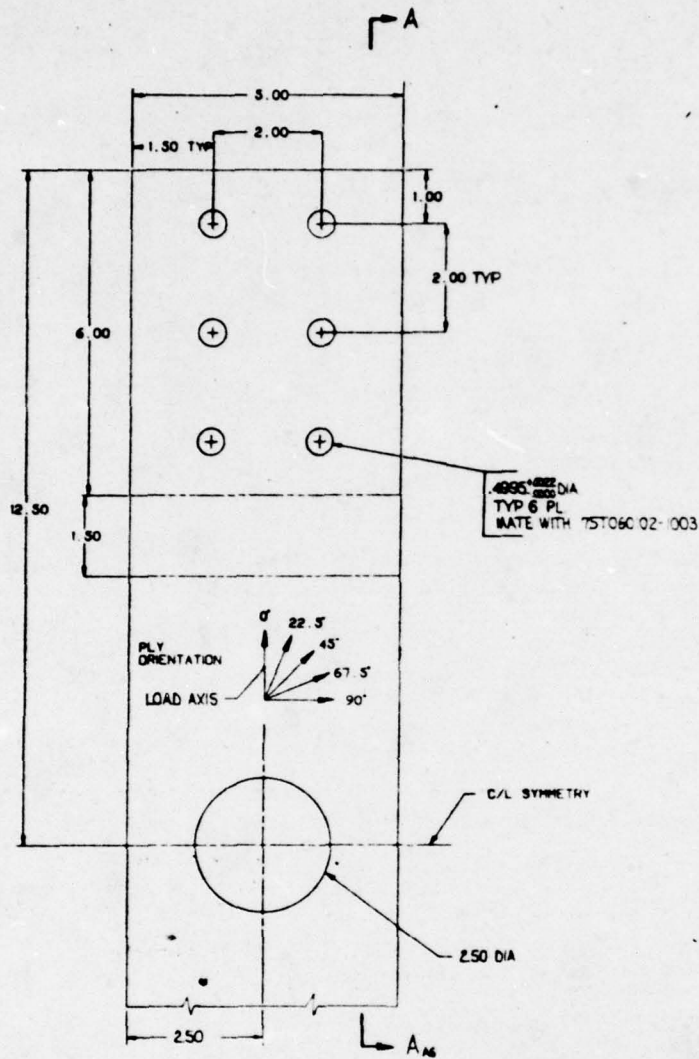
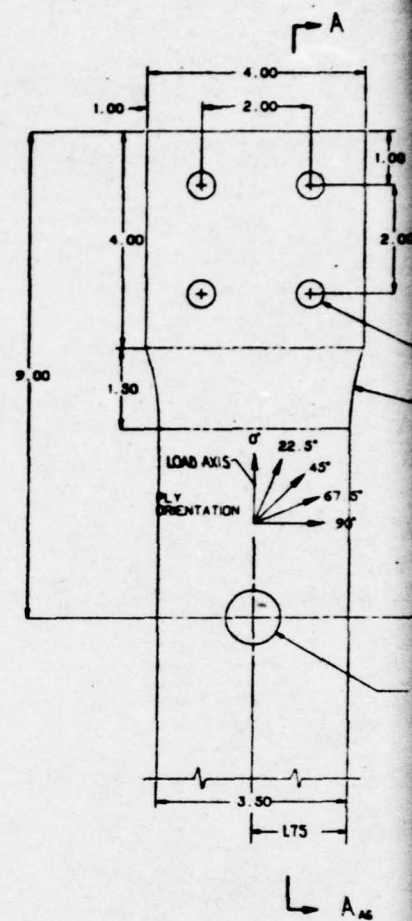
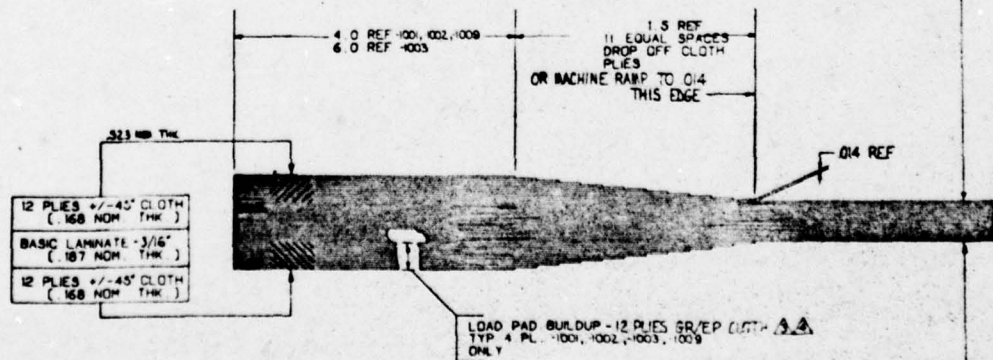
-1009 SPECIMEN

-1005 SPECIMEN

-1003 SPECIMEN

-1001 SPECIMEN

SECTION A-A  
(SCALE - NONE)

3/16" BASIC LAMINATE  
187 NOM. THK.

The engineering drawings for the test specimens, load plates, repair patches and backing plates, repair assemblies and compression specimen edge supports are presented herein.

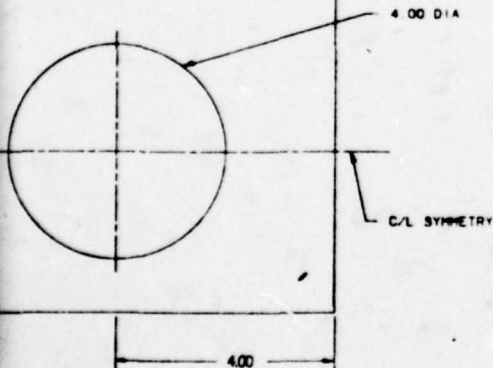
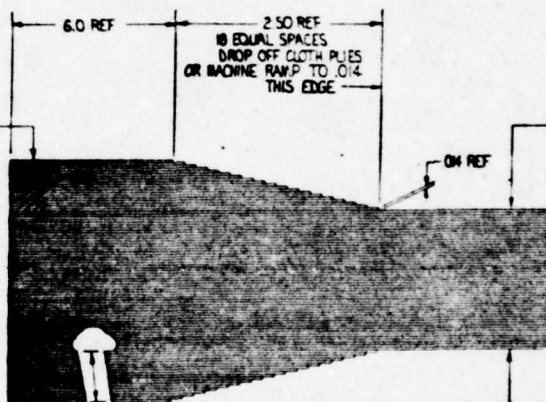
BASIC LAM RATE 1/2"  
(478 NOM THK)

19 PLYS ± 45° CLOTH  
(266 NOM THK)

LOAD PAD BUILDUP - 19 PLYS 6R/EP CLOTH  
TYP 4 PL - 1011, 1013, 1015, 1019 ONLY  $\Delta 4$

SECTION B-B  
(SCALE - NONE)

FIGURE NO	MCAIR DWG NO	TITLE
A-1	75T060101	Composite Specimens
A-2	75T060102	Load Plates
A-3	75T060103	Repair Patches for 3/16 Laminates
A-4	75T060104	Repair Patches for 1/2 Laminates
A-5	75T060105	Repair Assemblies for 3/16 Laminates
A-6	75T060106	Repair Assemblies for 1/2 Laminates
A-7	75T060107	Compression Specimen Edge Supports
